LAVA Pressure Transducer Trade Study

Samuel B. Oltman

LAVA Integration and Testing Fall Session

Date: 21-11-2016

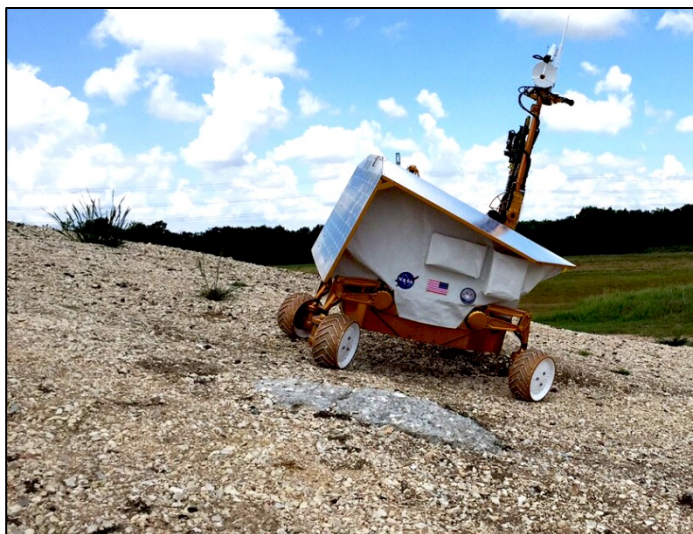
Figure 1. RP-15 demo rover
